# Turbidity Curtain: Only as Strong as its Weakest Anchor

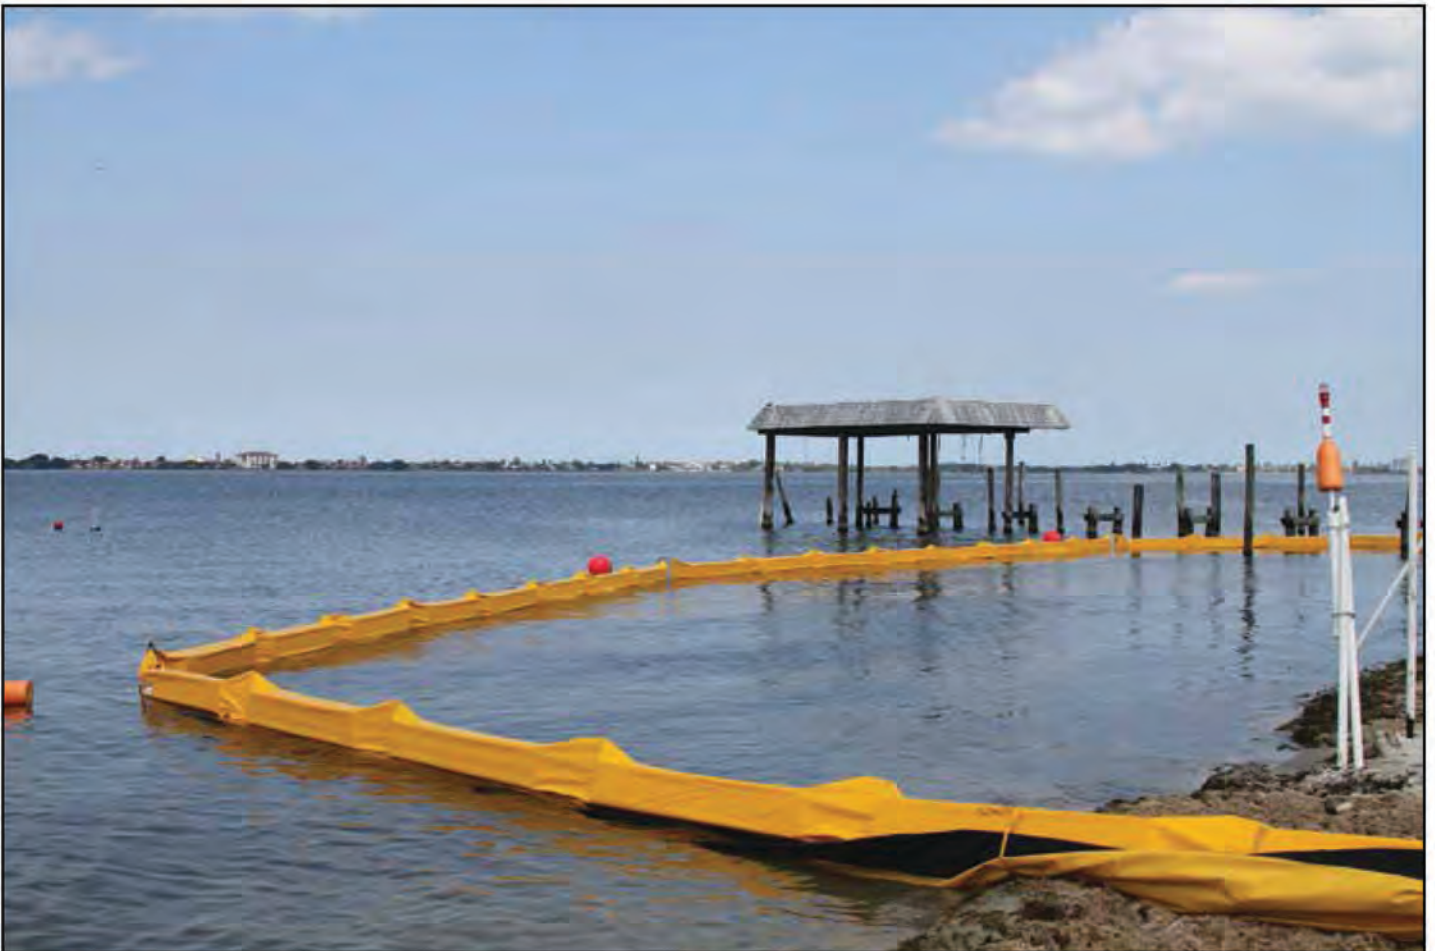
New turbidity curtain installed on site. Image courtesy of GEI Works.

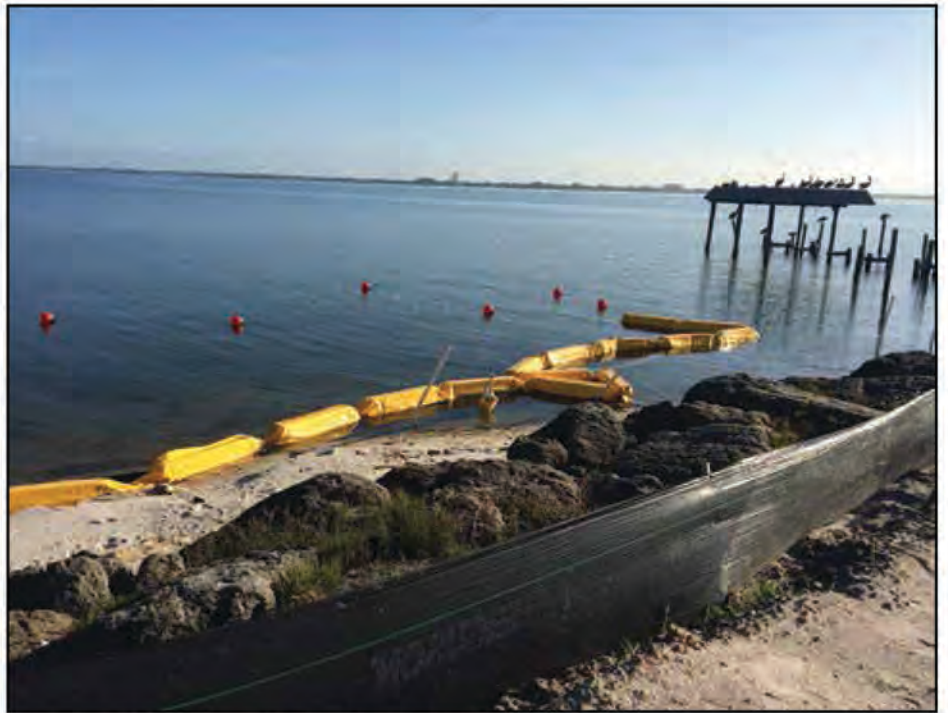
**Above: Turbidity curtain out of position due to ineffective anchoring. Below: Installed T-posts failing to hold the curtain in place. Images courtesy of GEI Works.**

When arriving on site, we were met with several sections of curtains that had been completely removed from the water and were washed up and sitting along the shore. Due to the anchoring procedure that had been implemented, the curtain had come in contact with several rocks causing tears in various locations along the barrier. The curtain's skirt was additionally weighed down with sand, creating tears between the bottom skirt and top float. The first goal was to understand what anchoring had occurred, assess why it had failed and implement a new anchoring pattern to try to secure the curtain.

With all of these considerations in mind, our team set out to reposition and anchor the curtain. The first step in remedying the existing site's curtain was to change the method and size of the anchors.

One of the major problems with the existing anchors on site was that they were simply too light to remain in place given the conditions. Rather than concrete buckets or light weight fluke anchors, our team installed a series of 22 pound fluke anchors. The correct weight of the anchors allowed them to properly deploy into the sandy location, securing and stabilizing the curtain in the best layout possible to perform in the conditions generated by northerly winds.

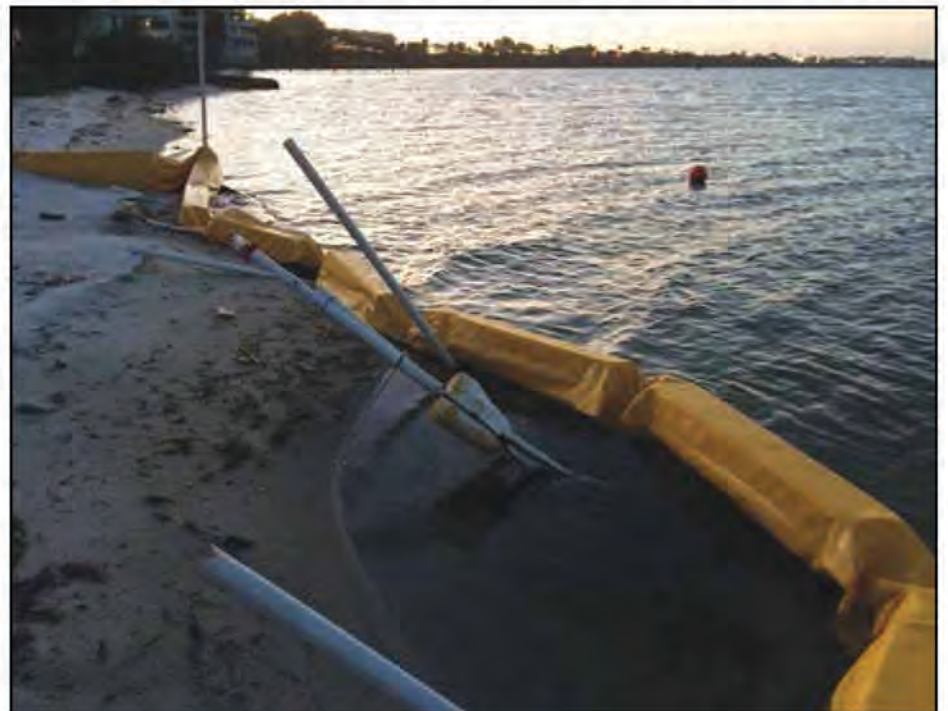
placed in front of the barrier. Posts were driven into the sand periodically in front of the curtain creating a wall in front of the curtain. The goal was to prevent the curtain from moving past the stakes and onto the shoreline. However, due to the weight of the curtain, the force of the current and instability of the anchors, many of the stakes began to slant and fall causing them to be overcome by the curtain and ultimately useless.

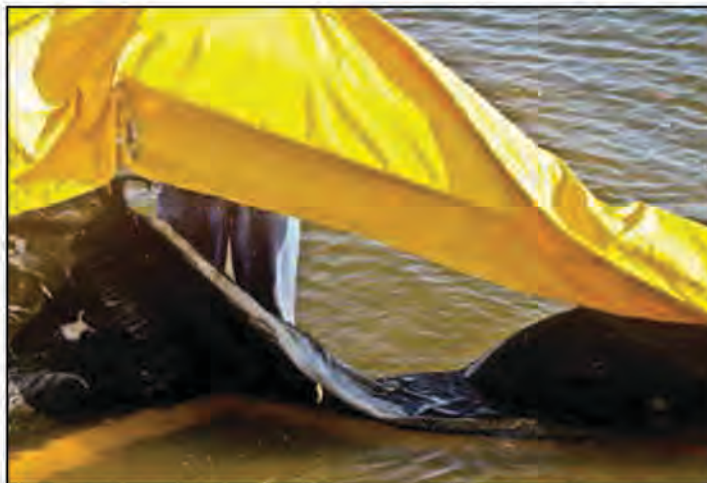
Both the concrete filled bucket and fluke anchors were installed by attaching the anchor directly to the buoy with a short chain and the buoy directly to the bottom of the curtain with rope. There are two challenges with this method of anchoring in the location. The first is the short attachment of the anchor directly to the buoy. Buoys are subject to both waves and tides causing them to bob up and down in the water. Due to the light weight of the anchors, sandy bottom, and the buoy being positioned directly above the anchor, the anchor was easily pulled out of the sand. In addition, the attachment of the anchor to the bottom of the curtain caused an unnatural pull of the curtain towards the bottom of the water. With the anchoring pulling the curtain down and the waves pulling the curtain up, the opposing forces caused the barrier to tear between the float and the skirt.

**Tear between the float and the skirt. Image courtesy of GEI Works.**

Rather than installing the anchor directly beneath the buoy, our team attached the anchors to a chain and the chain to a long mooring line. This line was made eight times the length of the depth of water to give the anchor enough slack to accommodate water movement. A secondary painter line attached the curtain to the buoy at a

distance of approximately five feet. This set up allowed the buoy to perform as a shock absorbent, reducing material fatigue on the curtain.

For most curtains, the recommended method of anchoring is through a top connection plate or dedicated anchor point. Top attachment helps keep the barrier in position without adding influencing weight or pressure to the bottom skirt. This is important to allow the skirt to billow with water movement. Since no existing anchor points were built into the curtain, the team installed anchor points manually on field by clamping the anchor point to the top of the curtain to ensure load transfer through tension cables to shore.

For portions of the torn curtain, our team additionally provided the site with our manufactured heavy duty Type 3 barrier. The curtain featured all the same components, but altered a few portions to match the conditions of the site. The first was the movement of the tension cable from the top to the bottom of the float. The second was the addition of universal

bulk slide connectors instead of top connection plates. These changes ensured the correct load transfer from the curtain to the anchor.
