Silt Curtain Protects Historic Blue Hole

Repairing the Scour Hole & Levee at the Center Crevasse Location

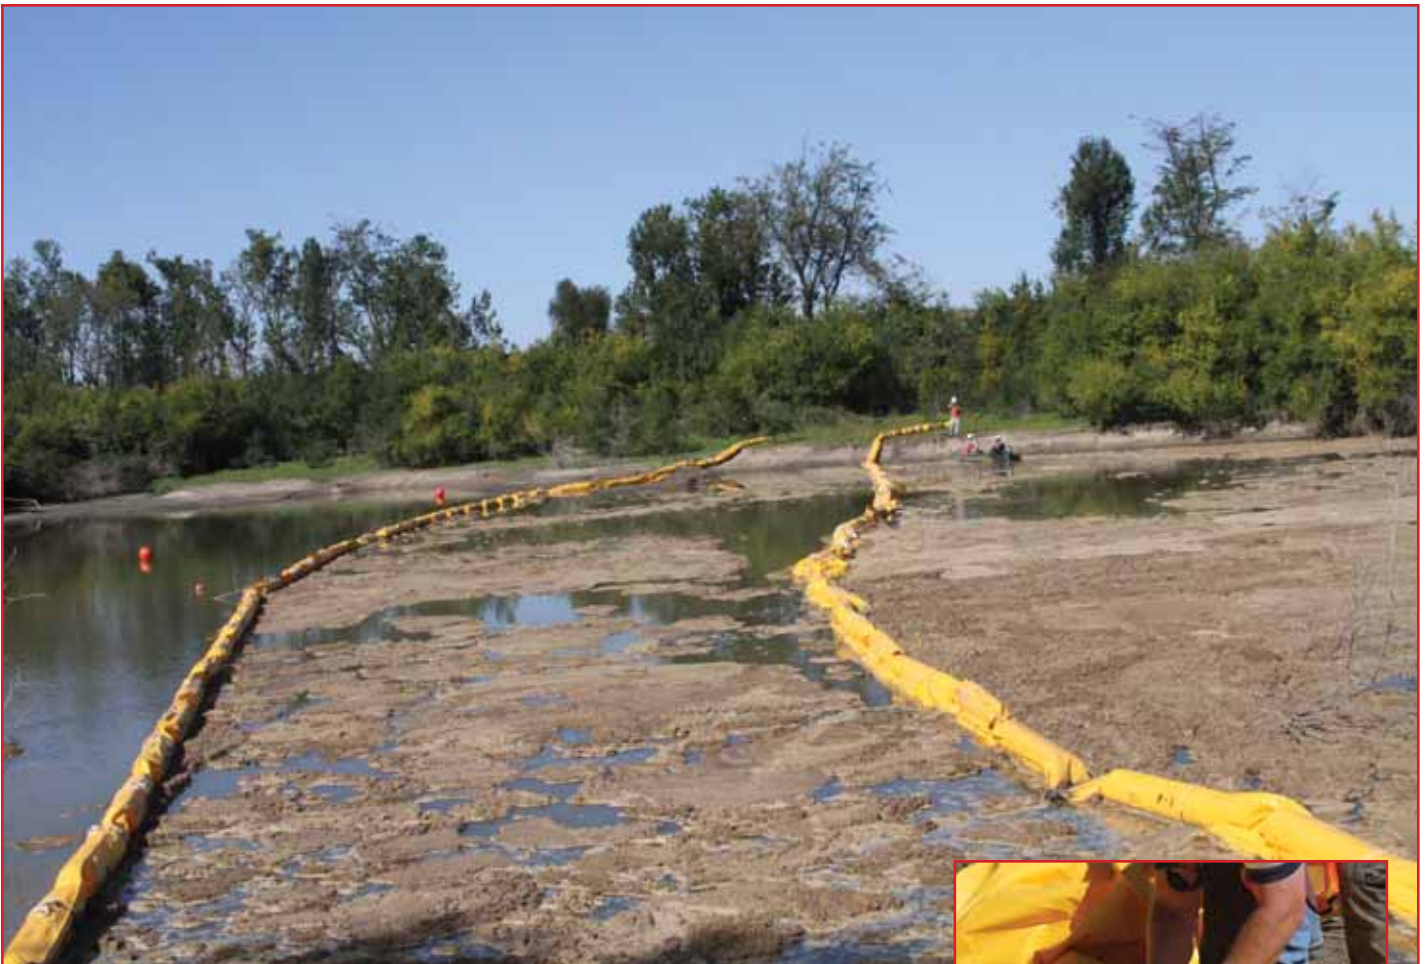
Above: Silt curtains installed parallel between the Historic Blue Hole and the scour hole. **Inset:** Sections of silt curtain being joined together. Images courtesy of Granite Environmental, Inc.

In addition, the large levels of sand and sediment being used to fill the scour hole included fine sediment that created a high level of suspended solids. Due to the magnitude and quality of the silt and sand floating within the scour hole, a second barrier was installed parallel to the first barrier. This curtain acted as a second line of defense to further control materials and protect the Historic Blue Hole. In order to keep the two parallel curtains apart, each curtain was anchored separately with a rope strung between the two curtains.

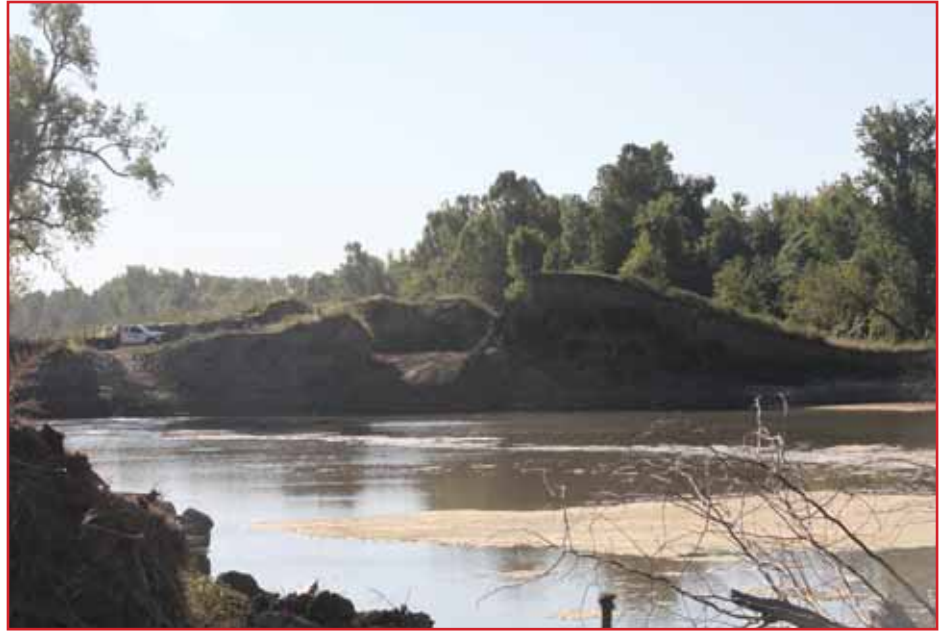
Location prior to installation of the turbidity curtain.

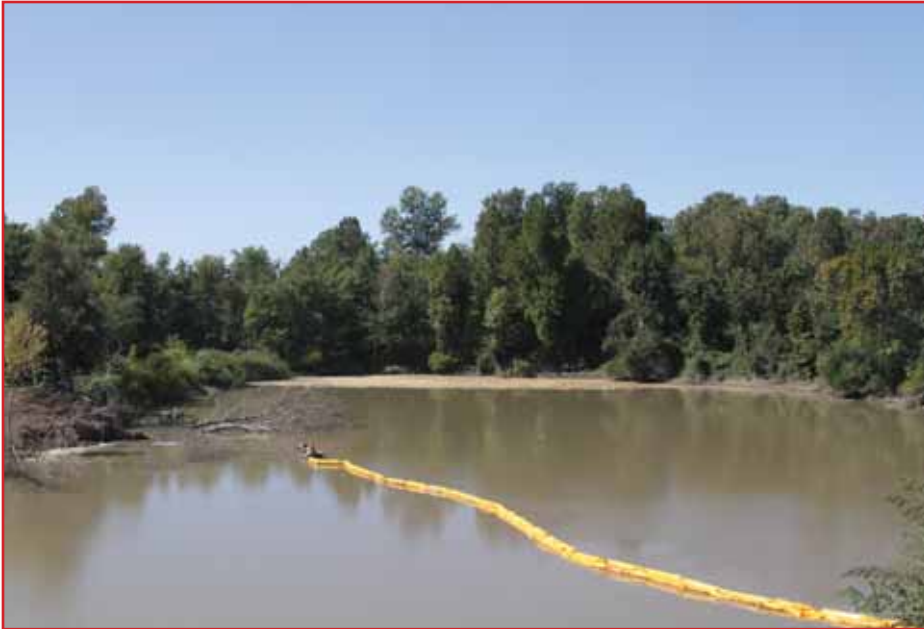
Silt curtain being deployed. Image courtesy of Granite Environmental, Inc.

The curtain was now ready for deployment. Before towing the curtain out, the skirt portion of the barrier was furled up to the top flotation. This made the curtain easier to tow and helped prevent the skirt from hitting any surrounding rocks or debris. The curtain was then towed out across the length of the hole. Ends of the barrier were anchored on one side to nearby trees and on the other side to concrete blocks. The curtain was additionally anchored periodically along the length of the barrier to help keep it in place during filling of the hole.

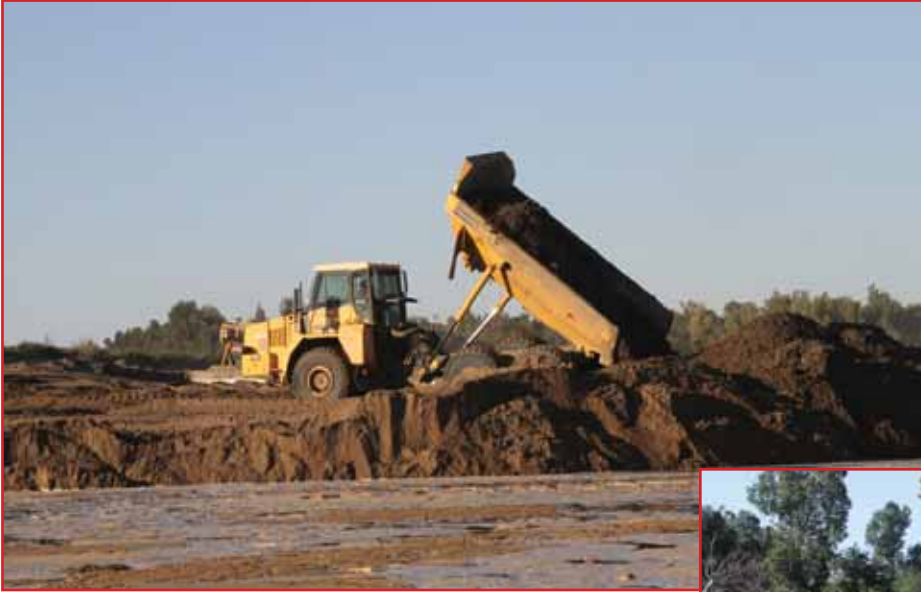
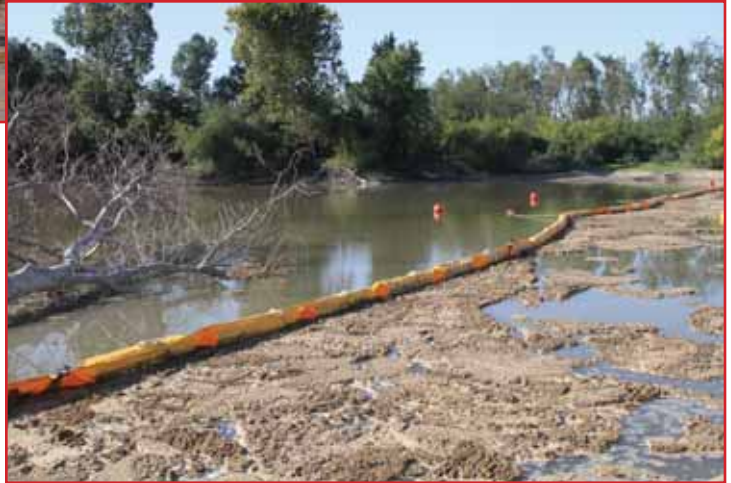
Top: Filling of the scour hole. Right: Installed silt curtains help prevent spreading of materials during scour hole filling. Images courtesy of Granite Environmental, Inc.

Once the silt curtain was in place, the scour hole continued to be filled until it reached pre-flood elevation and became level to the surrounding area. After this was completed, the levee could then be re-
